Final Report

CALFED Water Use Efficiency Program

Yolo County Resource Conservation District Pilot Program 2001

May 2002

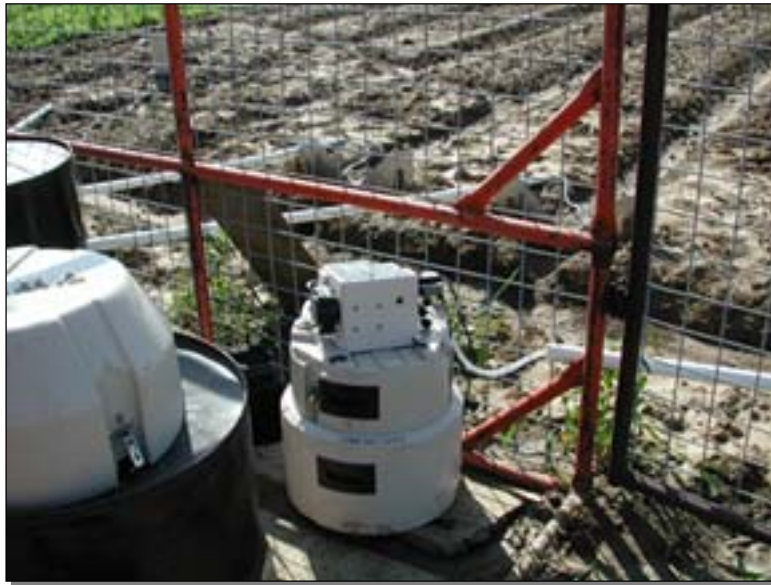
Figure 1: The automated water sampler (American Sigma Model 900MAX)

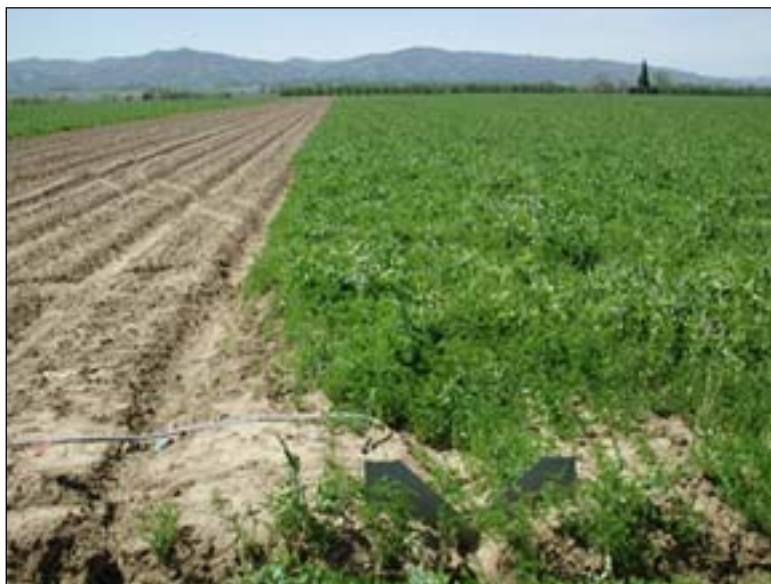
Figure 2: A picture of the study area showing a cover and non-cover crop sections with weir in foreground.

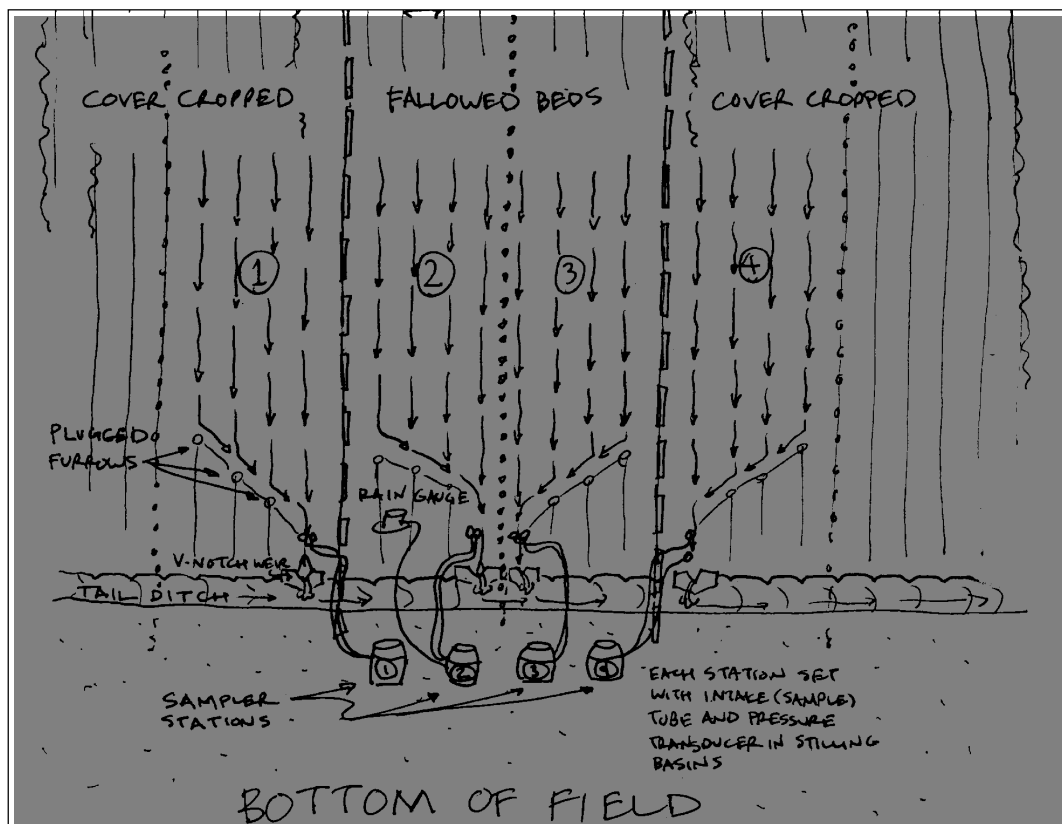
Figure 3: Furrow groupings and sampling station arrangements at cover crop evaluation site.

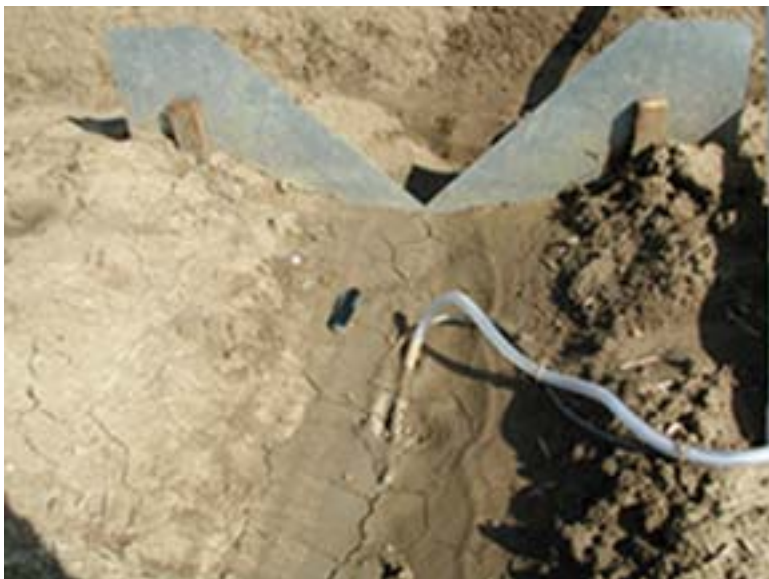
Figure 4: Cover Crop runoff measurement station with 90-degree V notch weir, the intake tube of the sampler, and the pressure transducer. (note inundation with sediment and Swiss army knife for scale)

Accurately measuring low runoff rates and shallow streams such as those leaving furrows from winter rainfall is generally problematic. Runoff flows observed in this Pilot Program typically varied less than an inch in depth when spilling over the weir. The margin of error for the transducers is approximately 0.276" (in depths between 0-11') or over 25% of the measured water levels in this application. This is a novel application for such samplers and flowmeters, and despite its current weaknesses it bears further experimentation because of its usefulness in measuring flows and sampling water in surface irrigated systems at odd hours.

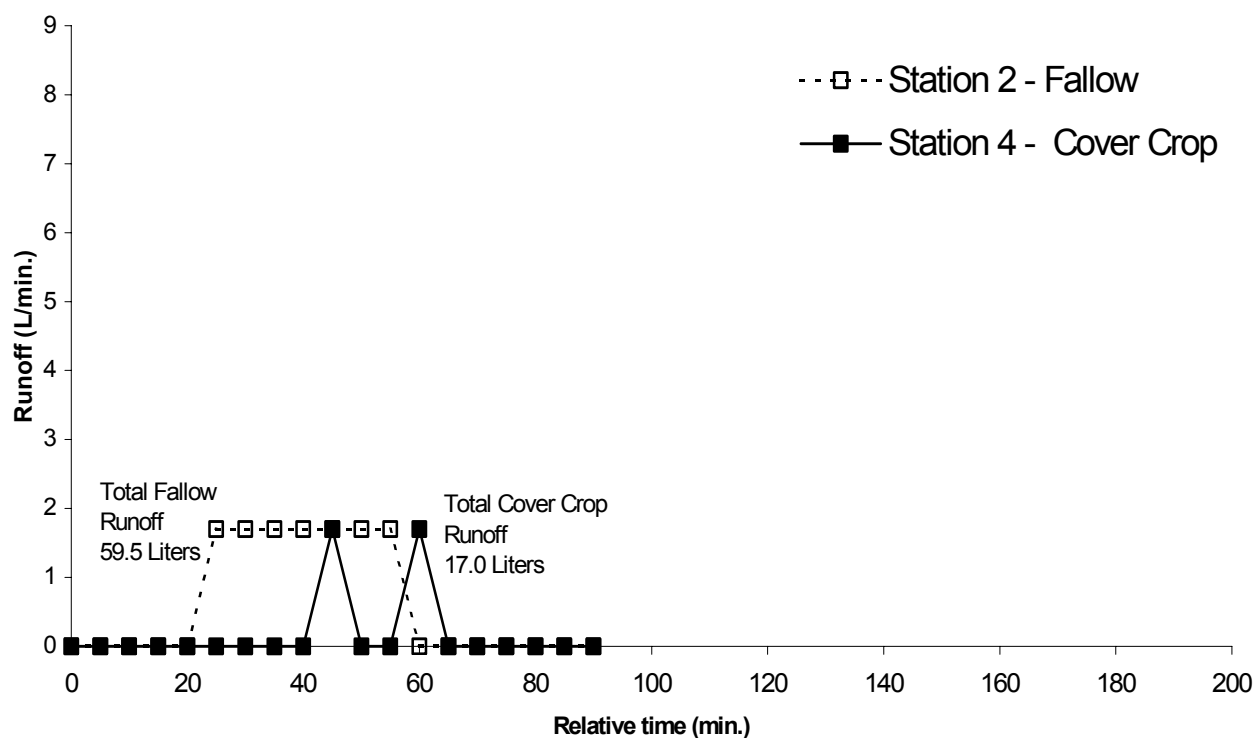
Figure 5: Runoff rate comparison between station #2 and #4 during the Feb. 21 rain event (7:30 AM - 9:00 AM)

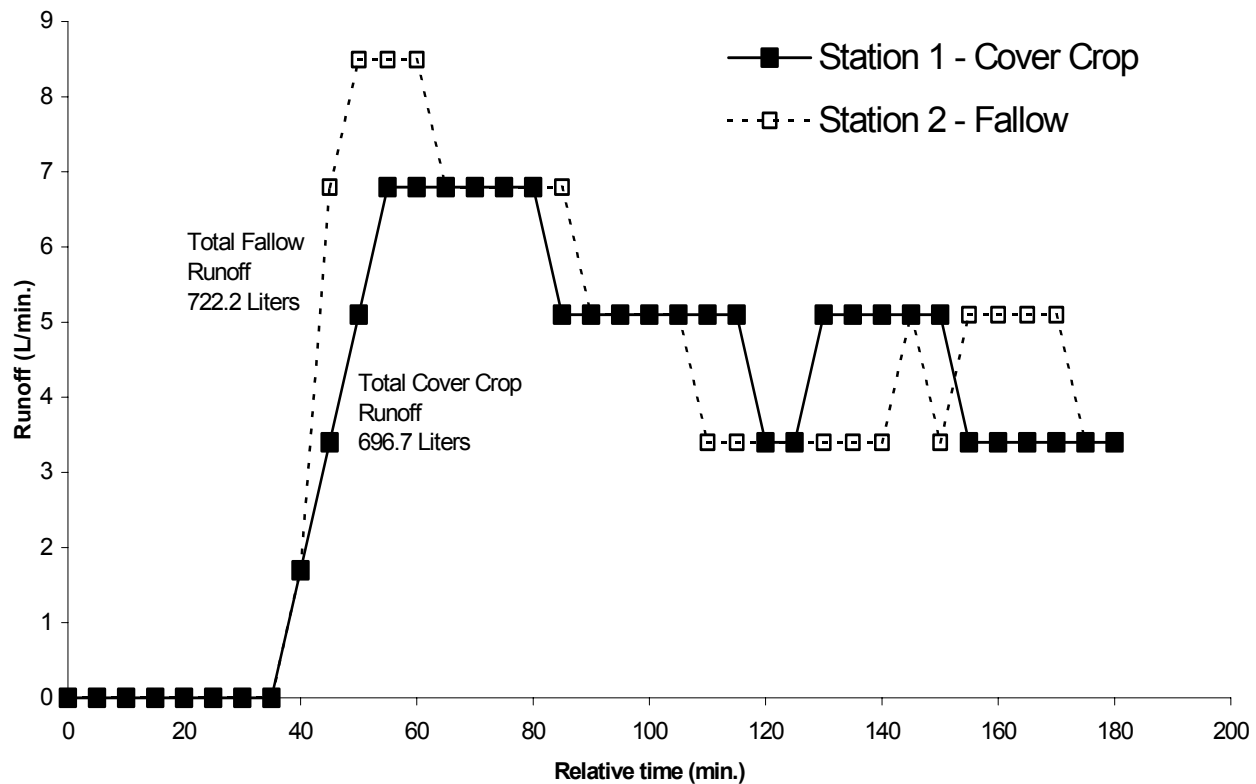
Figure 6: Runoff from stations #1 and #2 during the Feb. 20th rain event (1:00 AM - 4:00 AM).

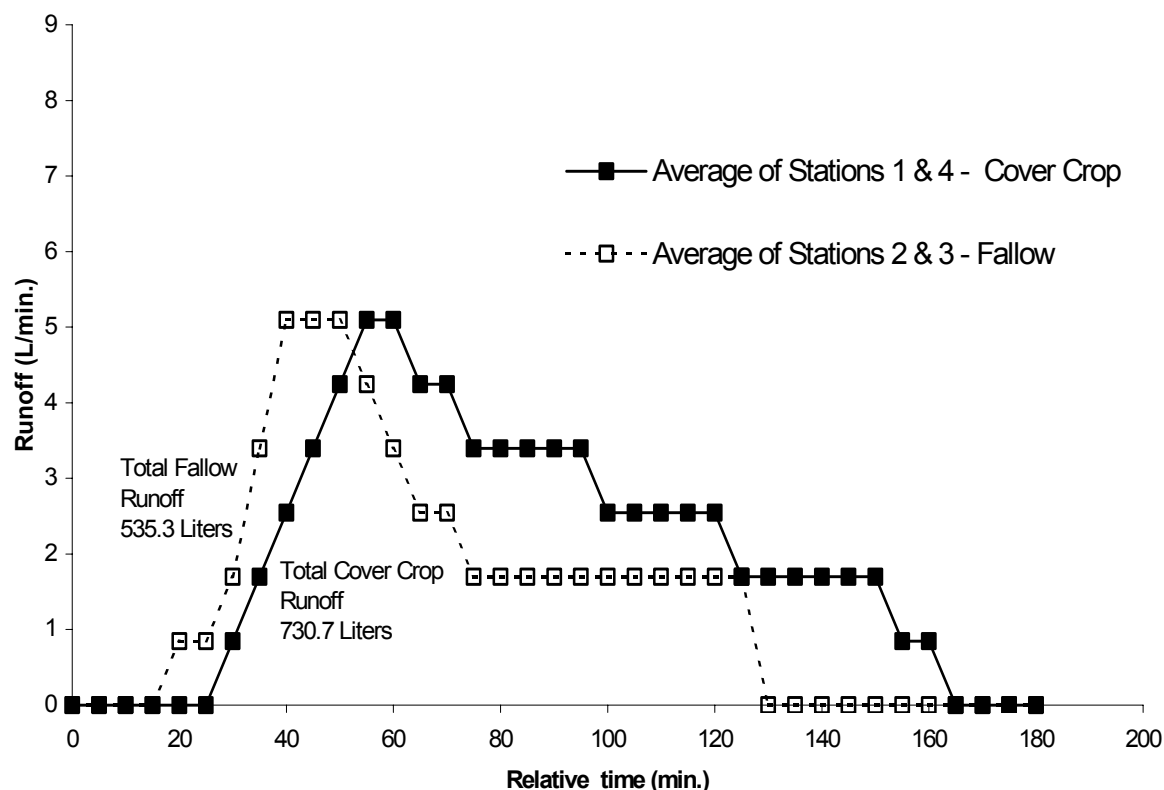
Figure 7: Average runoff from 2 different cover crop plots (stations #1 & #4) and 2 different fallow plots (stations #2 & #3) after the Feb 19th rain event (4:00 PM - 7:00 PM)

Figure 7 is another example of the effect of cover crop on the distribution of runoff over time, although the total flow from the cover cropped beds was higher in that instance than that of the fallow beds, contrary to expectation and experience. Runoff from the two fallow sites, stations 2 and 3, arrived earlier than runoff from the two cover cropped sites.

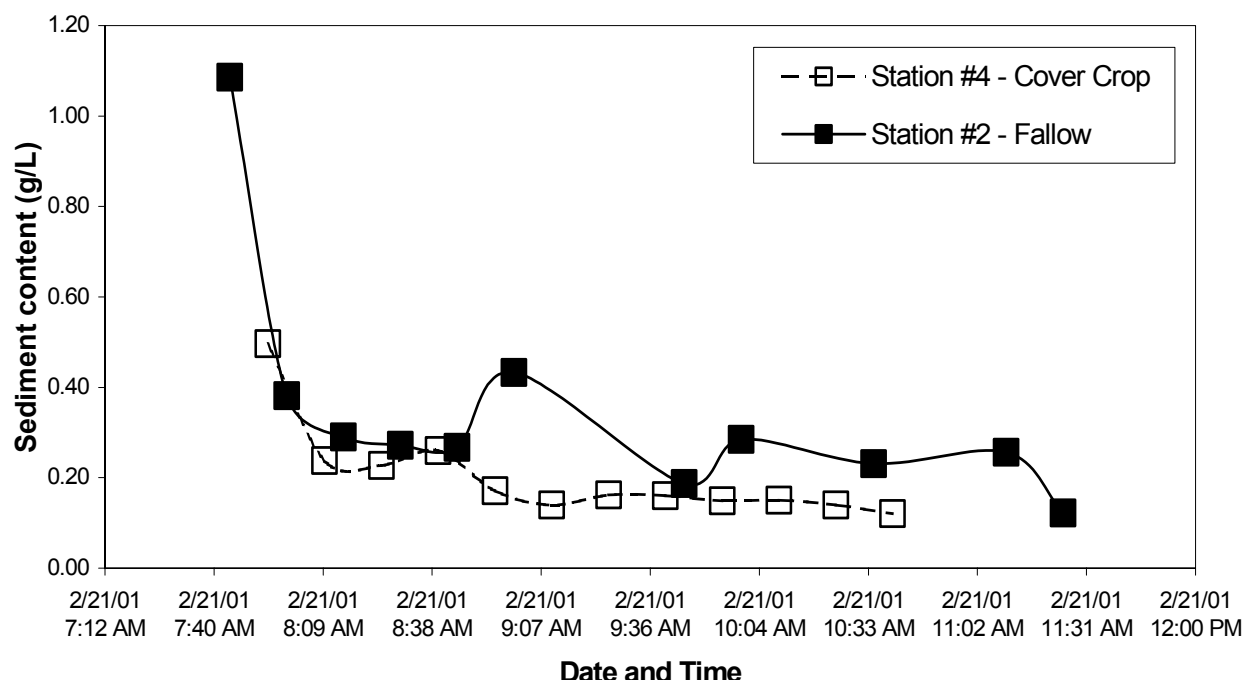
Figure 8: Sediment content in water running off at stations 2 and 4 for the Feb. 21 rain event

Sediment concentration in runoff flows was slightly attenuated during some of the storm events monitored, although not consistently. A major limiting factor in gathering adequate data for comparison was our learning curve in adapting the automated water sampling devices to function in low volume and shallow flow conditions such as those in the subject field. We could not identify another acceptable means by which to gather runoff quality data relative to flows during storms that peak at odd hours, and the ultimate potential for application of this technology for monitoring shallow flows seems positive. For the season of study, due to a combination of weather and technical difficulties, data from only one or two storm events was sufficient enough to provide graphical comparison, and those are included below.

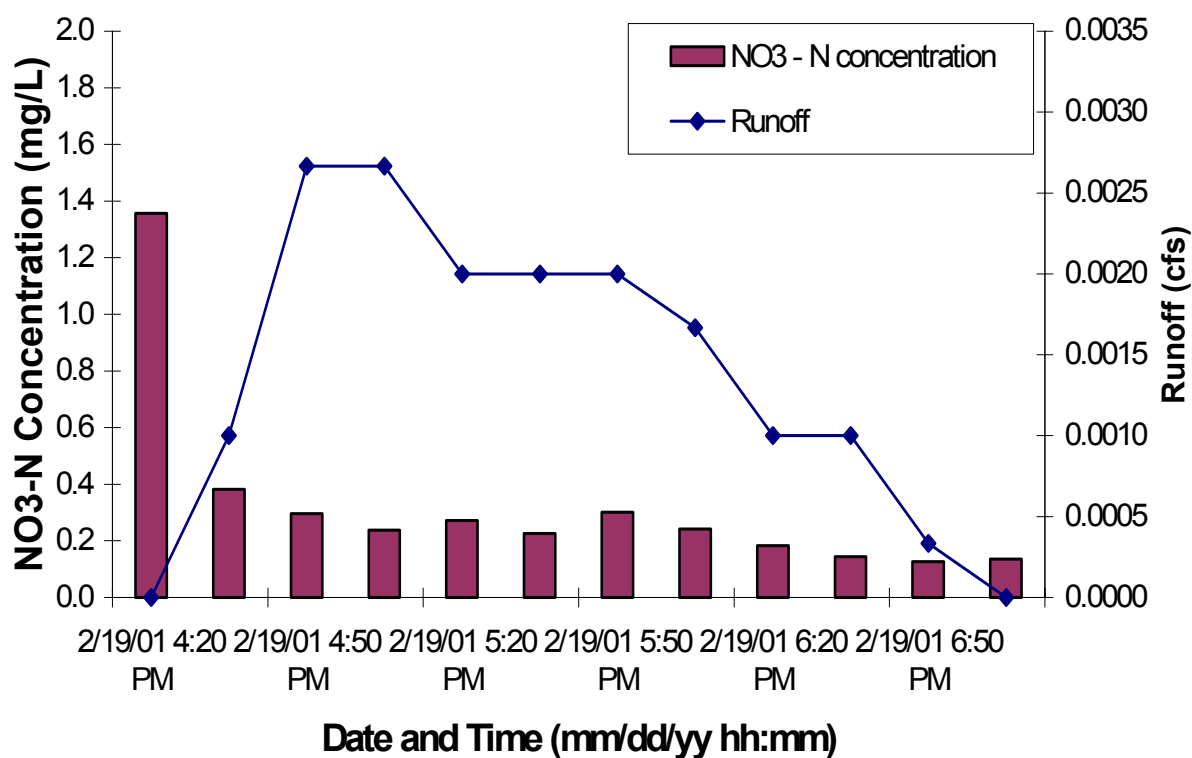
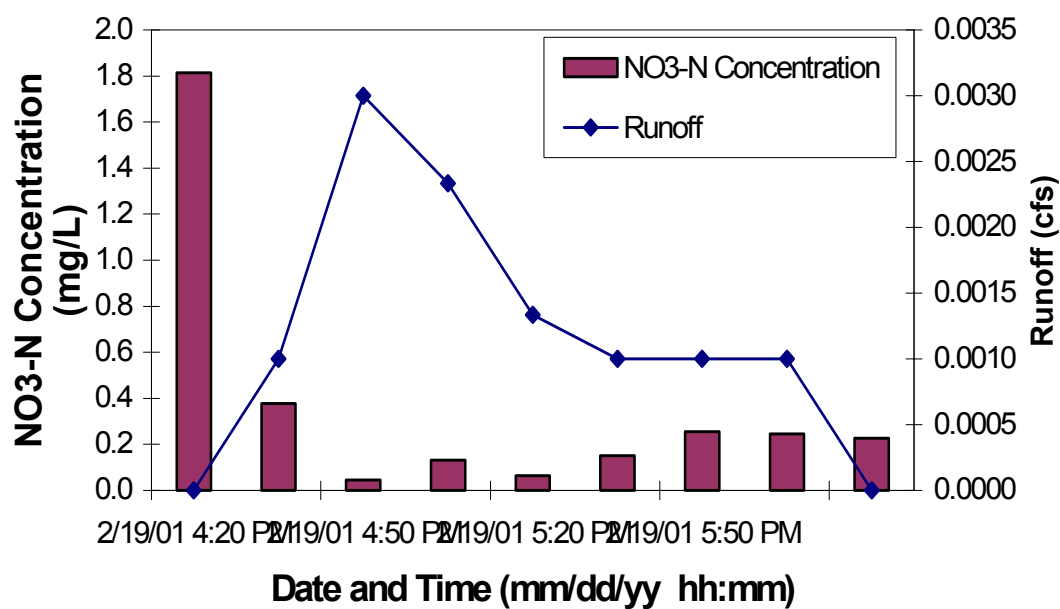
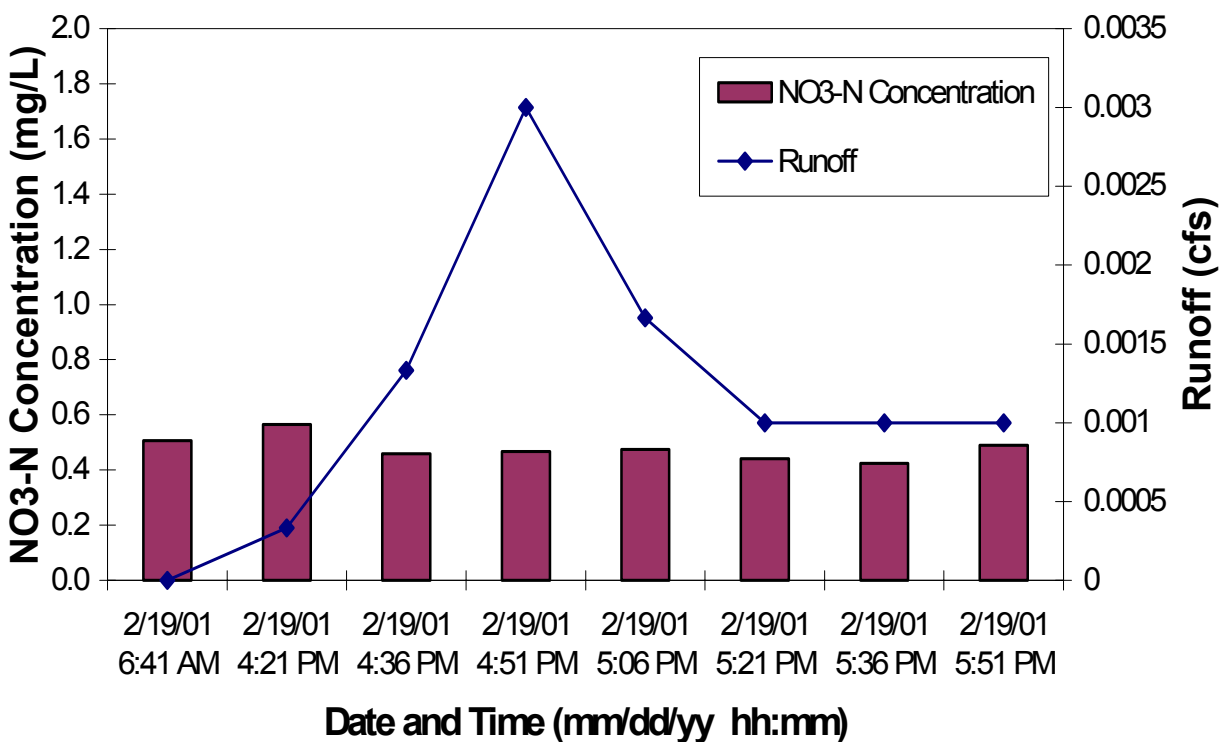
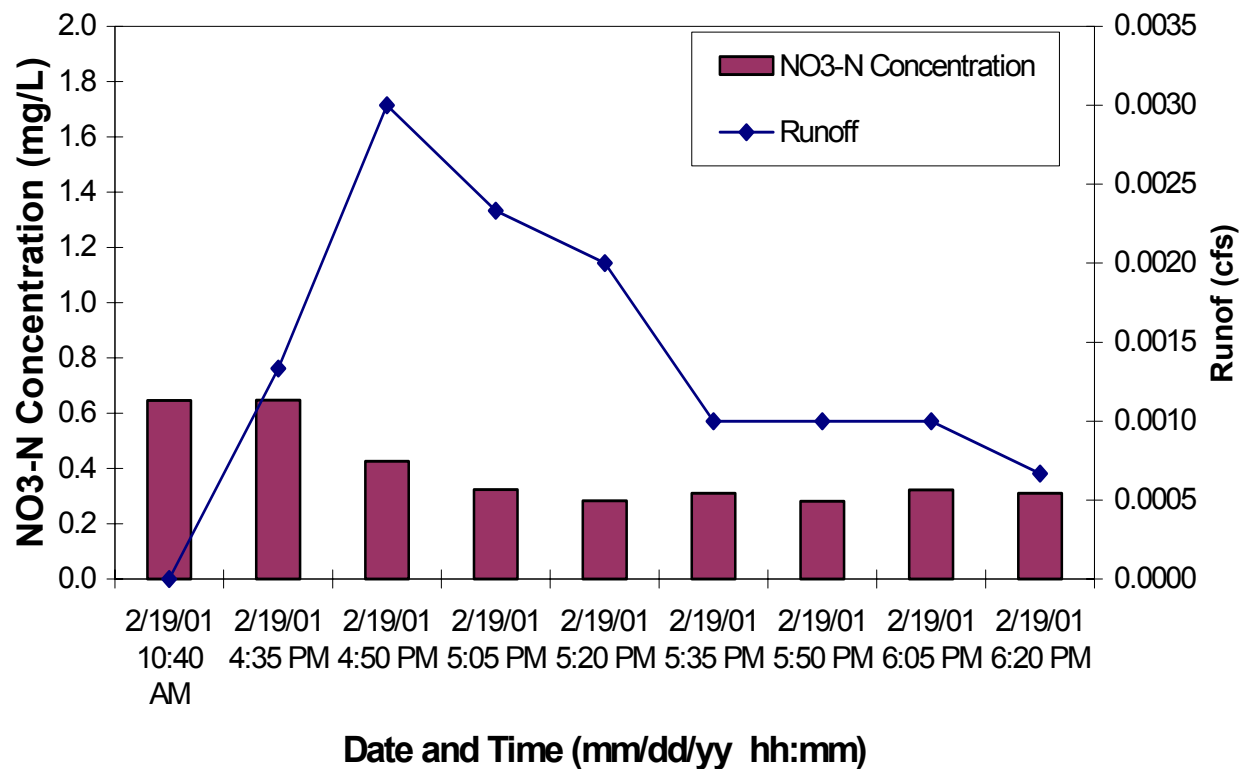
Figure 9: Station #1 (Cover Crop) Runoff (cfs) and Nitrogen concentration (mg/L) for Feb. 19, 2001 rainfall event.

Figure 10: Station #2 (Fallow) Runoff (cfs) and Nitrogen concentration (mg/L) for Feb. 19, 2001 rainfall event.

Figure 11: Station #3 (Fallow) Runoff (cfs) and Nitrogen concentration (mg/L) for Feb. 19, 2001 rainfall event.

Figure 12: Station #4 (Cover Crop) Runoff (cfs) and Nitrogen concentration (mg/L) for Feb. 19, 2001 rainfall event.

As for nutrient concentration, Pilot Program results were mixed. Of the one or two comparable storm events (Feb. 19, 2001 shown in Figures 9-12 below), the initial peak nitrate concentration was higher on average from the fallow treatments, making average Nitrate-N concentration higher from fallow beds even though Nitrate-N concentration was consistently slightly higher in flows from the cover crop treatment as compared to that of the fallow treatment. Possible cause of the increased levels of nitrogen in the cover cropped treatments could be from the vegetation, especially nitrogen-fixing legumes. Although the trial was designed to allow for at least some minor replication, inconsistencies in the actual sampling between the monitoring devices (combination of operator and manufacturer errors) provided us with only sporadically useful results, so the charts represented here in Figures 5-12 are best read as likely trends or observations until further research is conducted in the coming years with greater familiarity with the technology, consistent rainfall, and repeated identical trials.

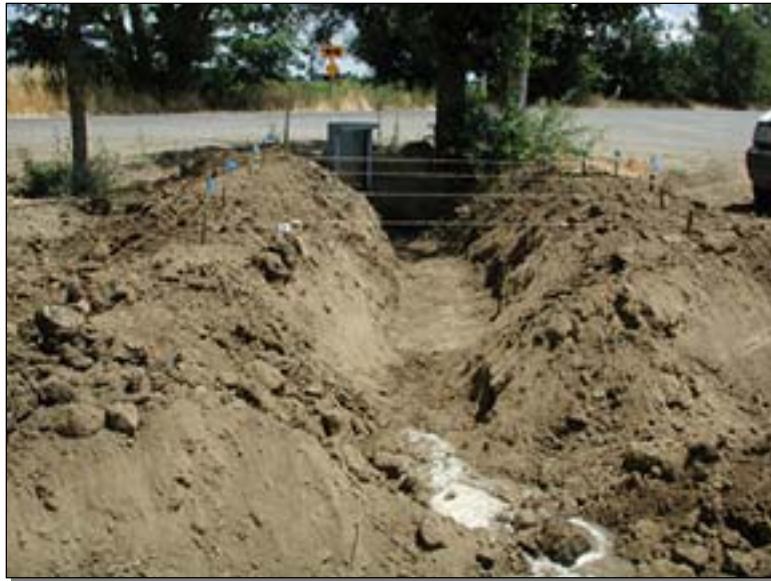
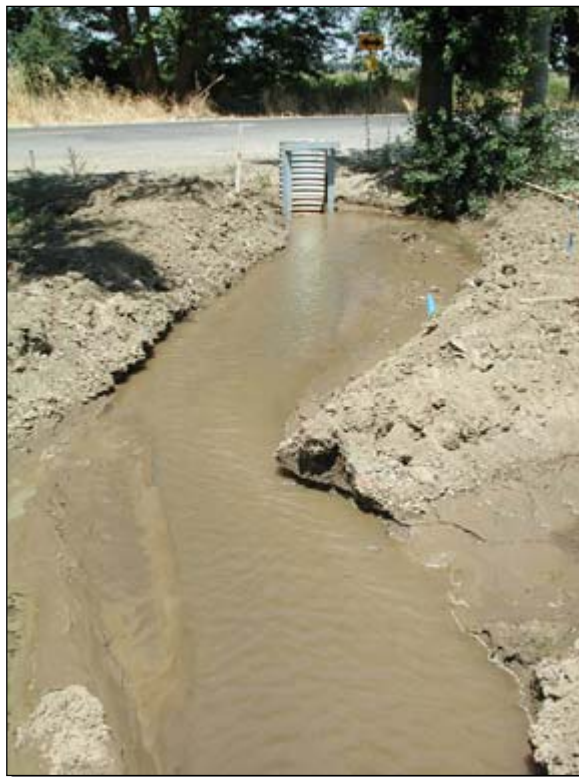
Figure 13: Sediment trap SM95 at the beginning of the season.

Figure 14: Sediment trap SM95 filled with runoff water

Sediment trap SM95 was 20 ft-long by 5 ft-wide and 4 ft-deep (Figure 13). This trap was constructed using an existing flashboard riser as the outlet structure for the sediment trap. No inflow structure was needed. After the first two irrigations the sediment trap filled with sediment. The farmer later cleaned the trap to allow for further usage but not before the next irrigation. While filled with sediment, the trap did not work properly until it was cleaned out. The trap filled so rapidly for two main reasons: 1) Its volume was not large enough to handle a 75-acre field; and 2) The irrigators failed in the first irrigation to manage the water flow rate from the gated pipe system they had used, which resulted in high volumes of runoff and therefore increased erosion. By the end of the irrigation season (4-5 irrigations) the trap was filled again.

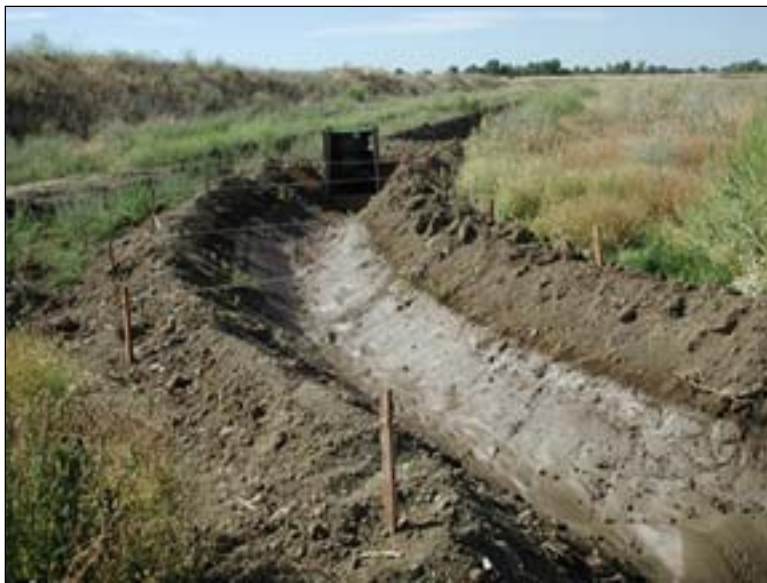
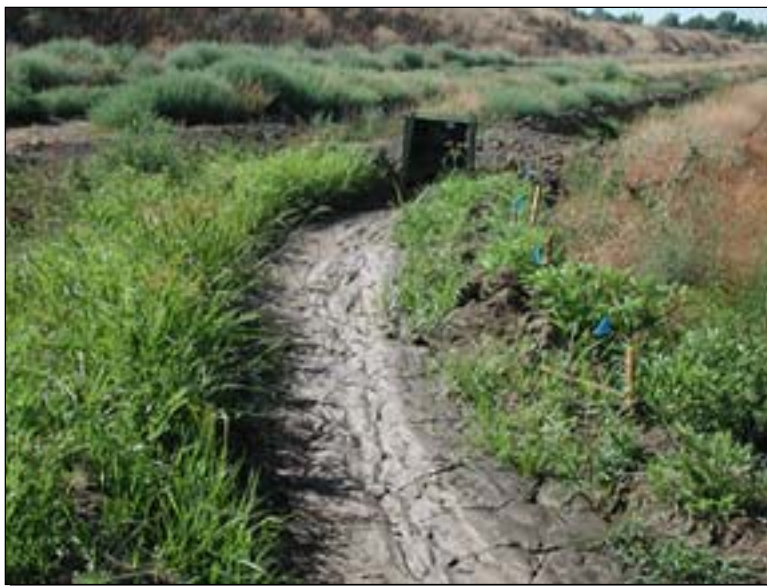
Figure 15: Sediment trap SMCC at the beginning of the season. Note lines over ditch for surveying.

Figure 16: Sediment trap SMCC at the end of the season.

Sediment trap SMCC was a 30 ft-long by 5 ft-wide and 2.5 ft-deep V-shaped ditch (Figure 15). The farmer did not clean this trap during the irrigation season, even though it needed cleaning out prior to the end of the season. One flashboard riser was installed at the trap outflow (Figure 16). This trap was more of an extended drain ditch rather than a settling pond. There was space for a wider pond at this site. Widening the pond would have increased its capacity and, as a result, its effectiveness.

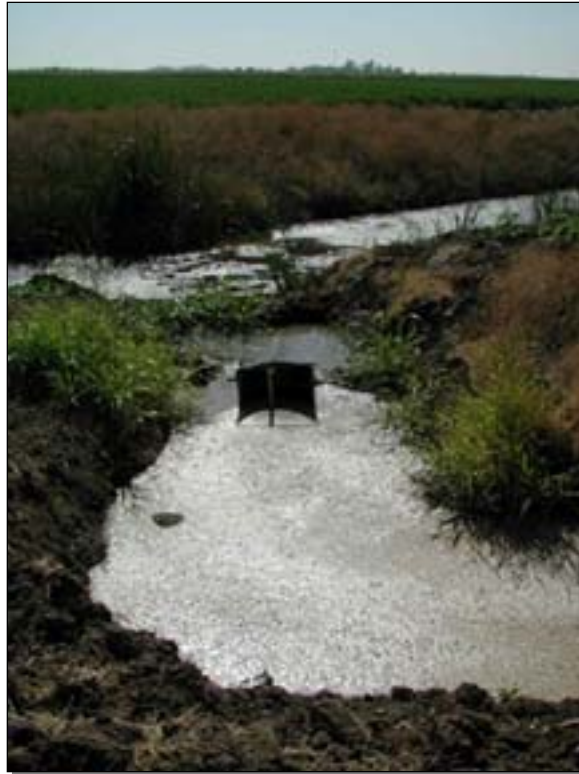
Figure 17: Sediment trap SB64 filled with runoff water. Note backed up drain outlet.

Sediment trap SB64 was L-shaped, 110 feet long, 10 feet wide, and 3 feet deep (Figure 17). The design and dimensions of this site were sufficient relative to the area of the field (64 ac.). The trap was successful in terms of collecting sediment; however, sampling outflow was very difficult due to problems downstream of the site that caused water to pond all the time and back up into the sediment trap. (A beaver plugged a culvert downstream with debris.)

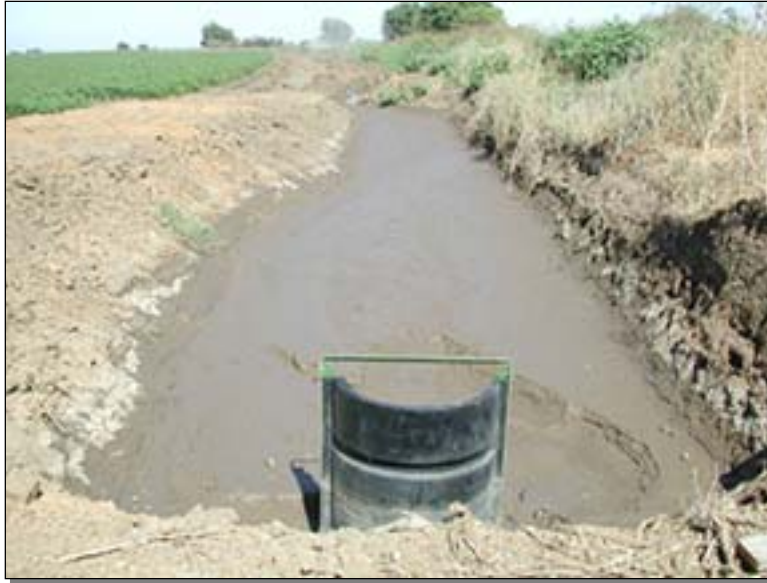
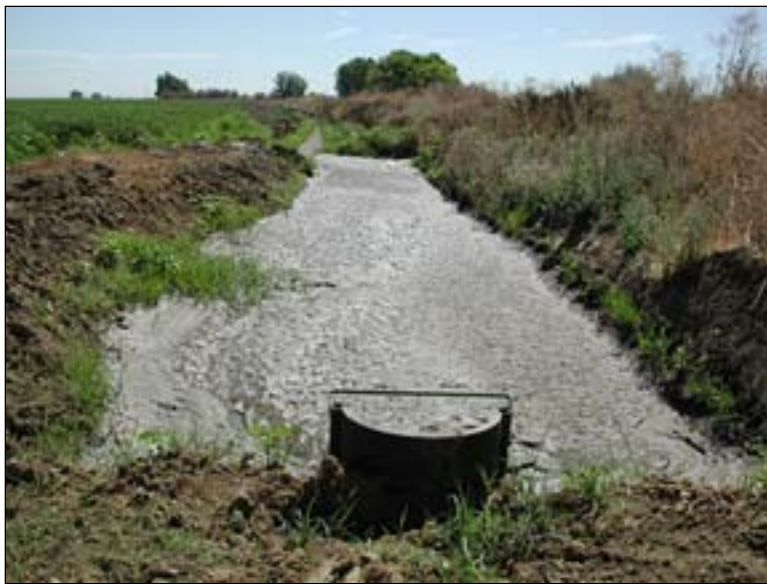
Figure 18: Sediment trap SBTC early during the season.

Figure 19: Sediment trap SBTC towards the end of the season

This sediment trap was 30 ft-long by 12 ft-wide with an average depth of 42 inches and a V-shaped cross section. A drop structure was installed at the outlet of the trap (Figure 18). It was located at the bottom corner of a 110-acre cotton and processing tomato field. The size of this trap was adequately large to allow for adjustments during the irrigation season to keep it functioning without requiring cleaning. This was important because it was otherwise impossible to clean this trap because the sediment remained saturated throughout the season.

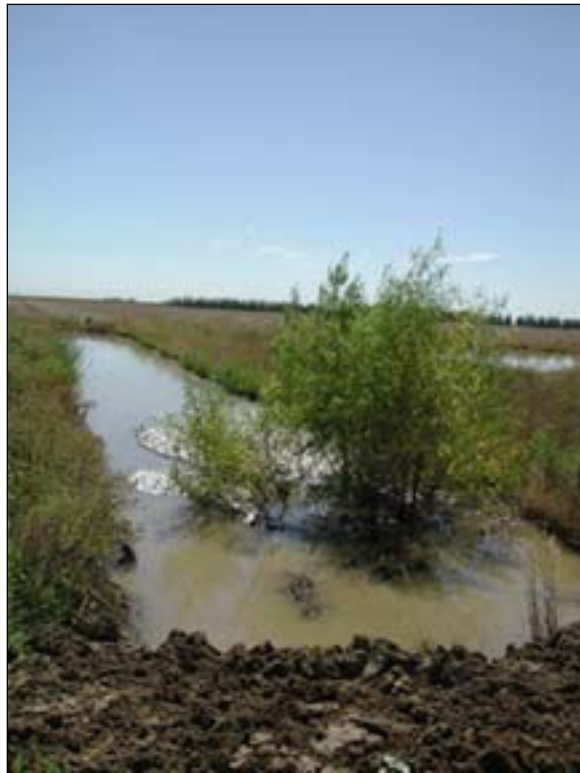
Figure 20: Sediment trap SROM filled with runoff water

This trap (Figure 20) was 50 ft long by 8 ft wide and 4 feet deep, and was located adjacent and upstream of the PROM tailwater pond (described in Section 4 of this task). An existing flashboard riser was used as the outlet structure and a new flashboard riser was installed at the trap inlet. Water leaving the sediment trap flowed directly into the PROM tailwater pond. The contributing field was a 50-acre conservation-tilled corn field.

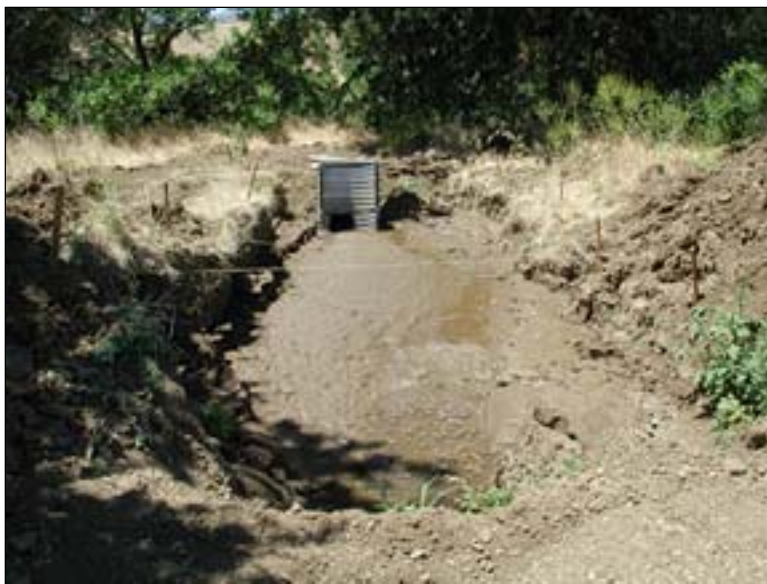
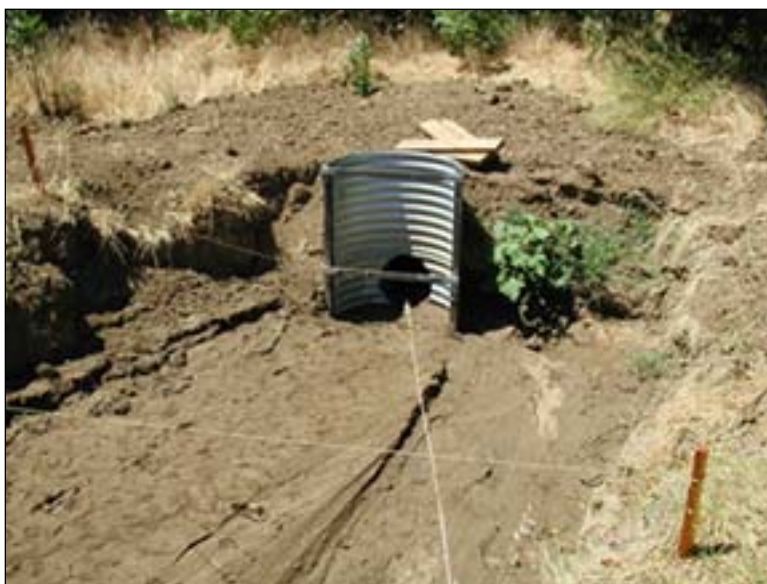
Figure 21: Sediment trap SRCH filled with sediment

Figure 22: A closer look at the outlet of sediment trap SRCH

This trap was 25 ft long by 10 ft wide with an average depth of 5 ft and a U-shaped cross section. A drop structure was needed at the down gradient end of the trap (Figures 21-22). An existing drop structure was used at the inlet of this trap, and the outlet pipe was modified to fit a flashboard riser for ponding and control. Water from this 28-acre tomato field drains directly into Chickahominy slough. This trap filled with sediment after the first two irrigation events and was not cleaned out. Although samples were not collected after that point, District personnel surveyed the captured sediment in the full trap.

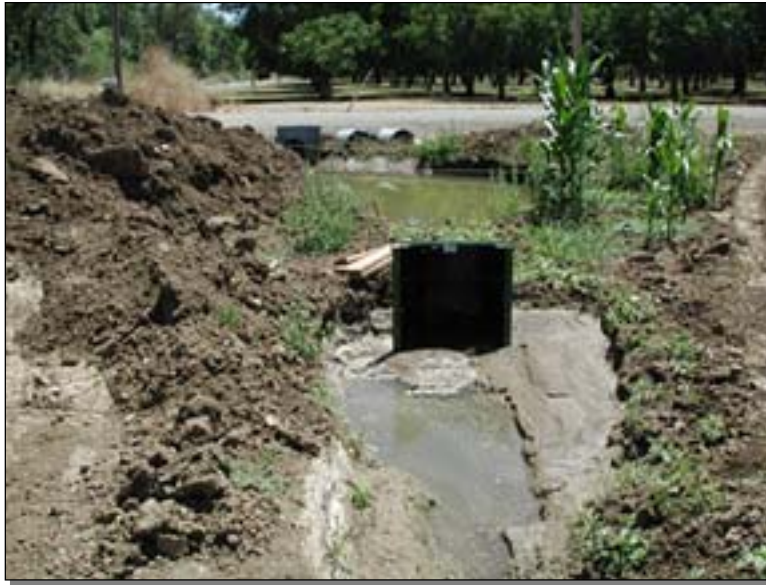
Figure 23: Sediment trap SRUS, note that the drop structure in the center of the picture is the trap inlet and the ponded water can be seen between the inlet drop structure and the outlet culverts under the road

This trap is 25 ft long by 10 ft wide and located at the corner of a 25-acre cornfield. A drop structure was installed as the inlet of this trap. An existing flashboard riser and culvert structure were used as an outlet (Figure 23). It was. Water from this field drains directly into Union School Slough. This trap was improperly designed and constructed because the drain level was higher than the inflow

level, resulting in the trap remaining full of water throughout the entire irrigation season. No samples or data were collected from this site.

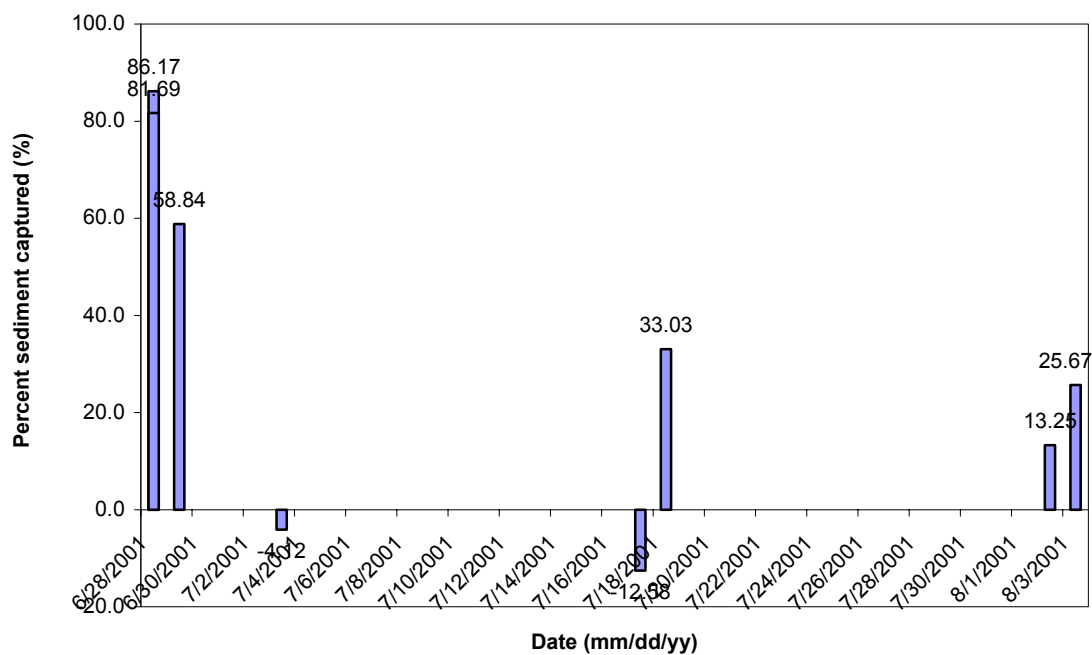
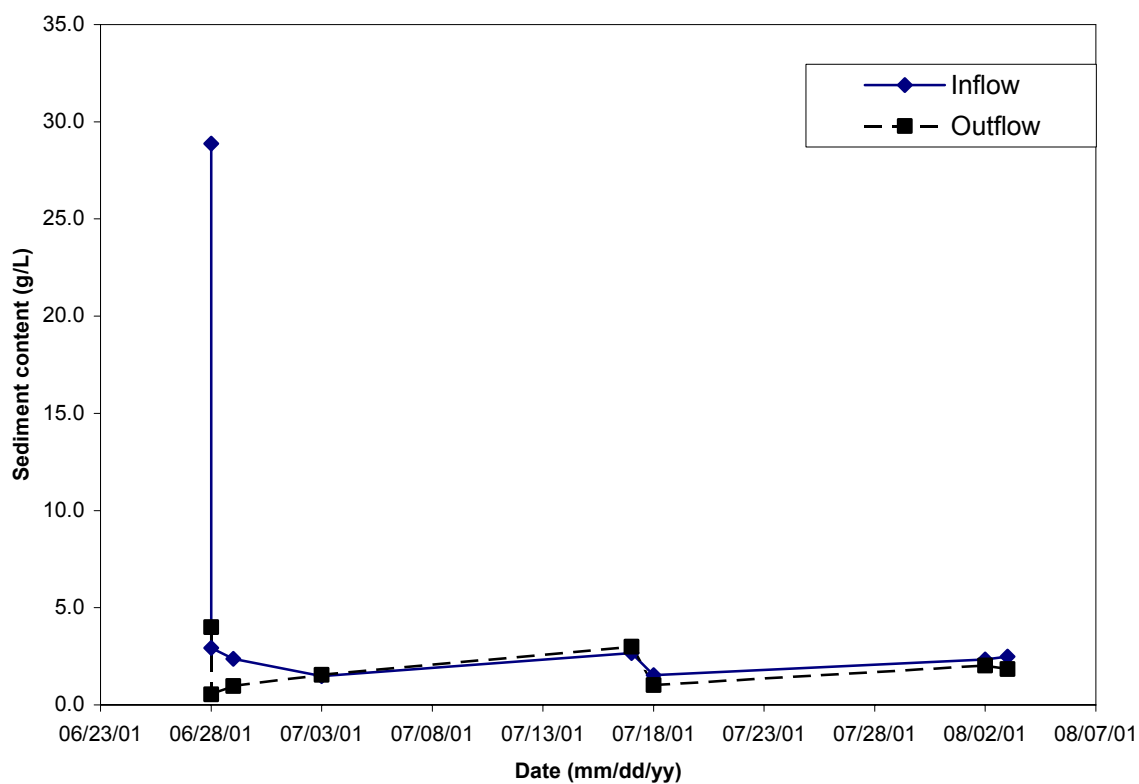
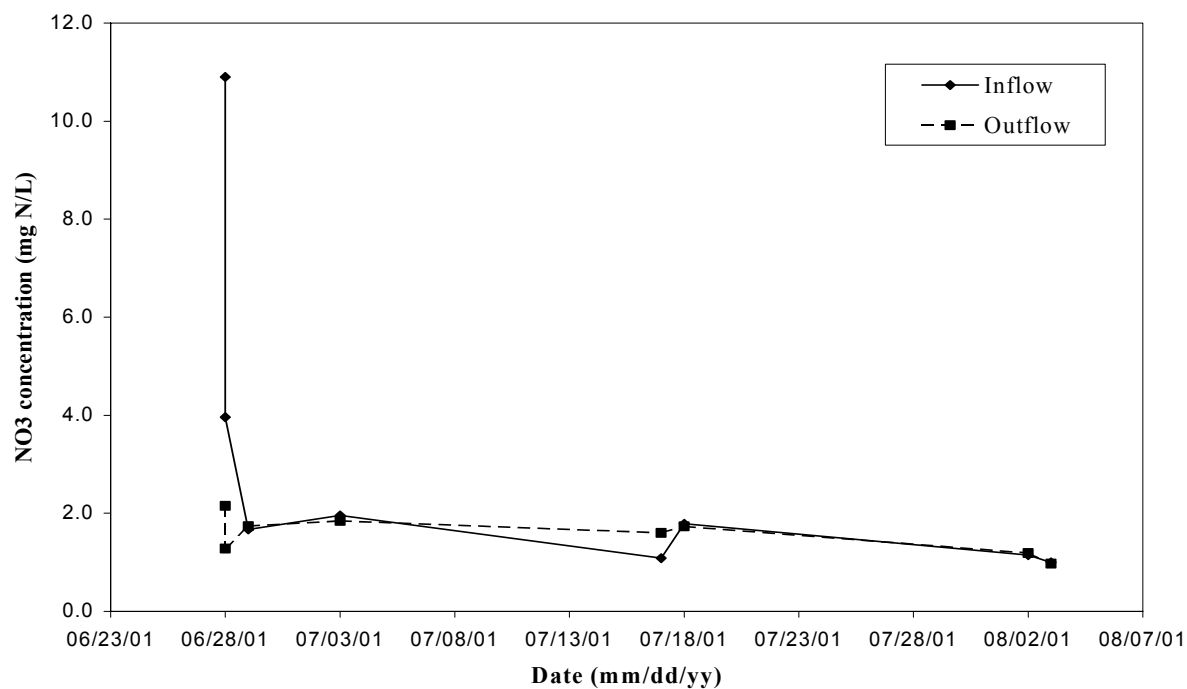
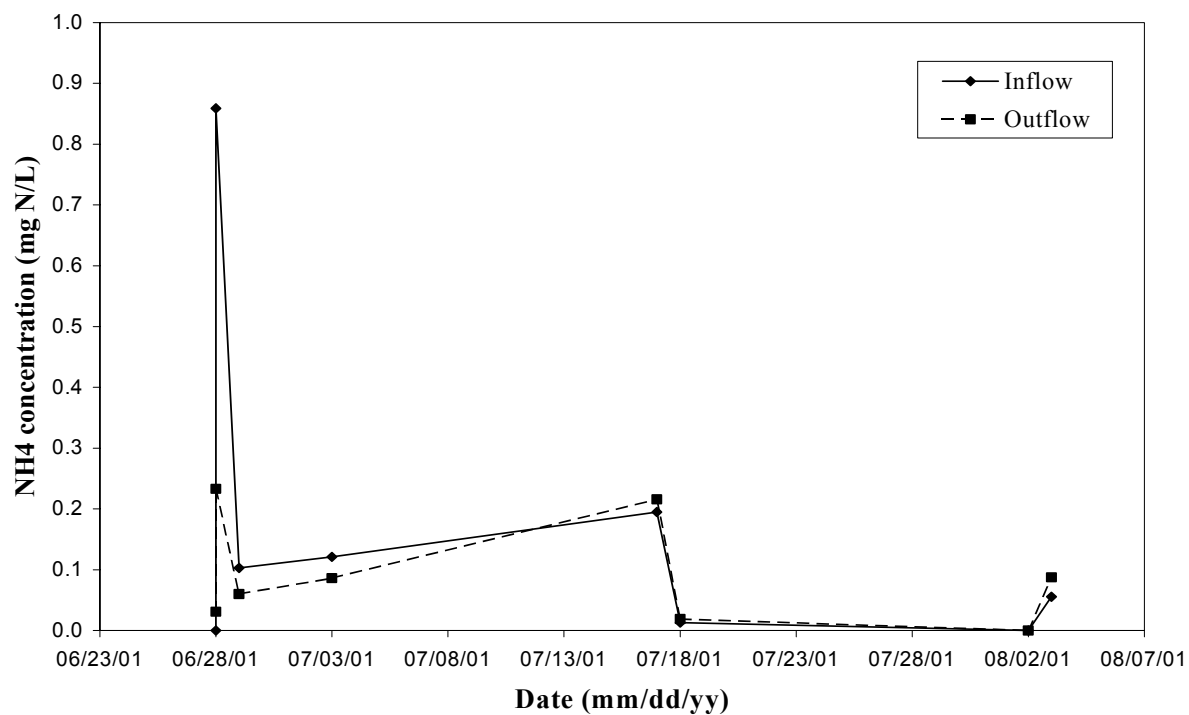
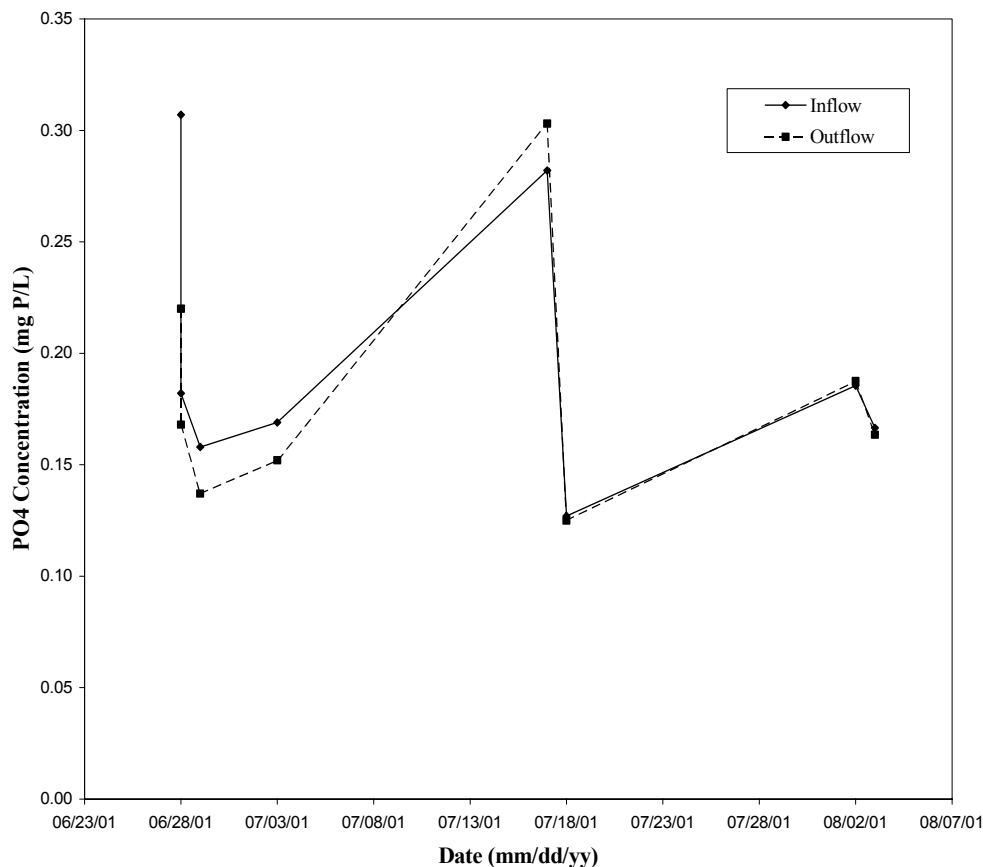
Figure 24: Sediment capture efficiency at the SM95 trap site.

Figure 25: Sediment content in samples collected from the SM95 trap site.

Figure 26: NO3 Nitrogen concentration in samples collected from the SM95 trap site.

Figure 27: NH4 concentration in samples collected from the SM95 trap site.

Figure 28: PO4 concentration in samples collected from the the SM95 trap.

concentrations were found to drop dramatically at the beginning of the season and then remain steady throughout the remainder of the season. The initial spike in NO_3 and NH_4 appears to have been attenuated by the trap, as evidenced by lower outflow than inflow values, but later irrigations appear not to benefit from the trap's presence in terms of nutrient capture. The concentration of PO_4 , however, did not show an observable trend. In this case, it fluctuated between 0.127 – 0.307 mg P/L.
